NATIONAL ADVISORY COMMITTEE FOR AERONAUTICS

TECHNICAL NOTE 3892

PERFORMANCE OF 110-MILLIMETER-BORE M-1 TOOL STEEL BALL
BEARINGS AT HIGH SPEEDS, LOADS, AND TEMPERATURES

By William J. Anderson

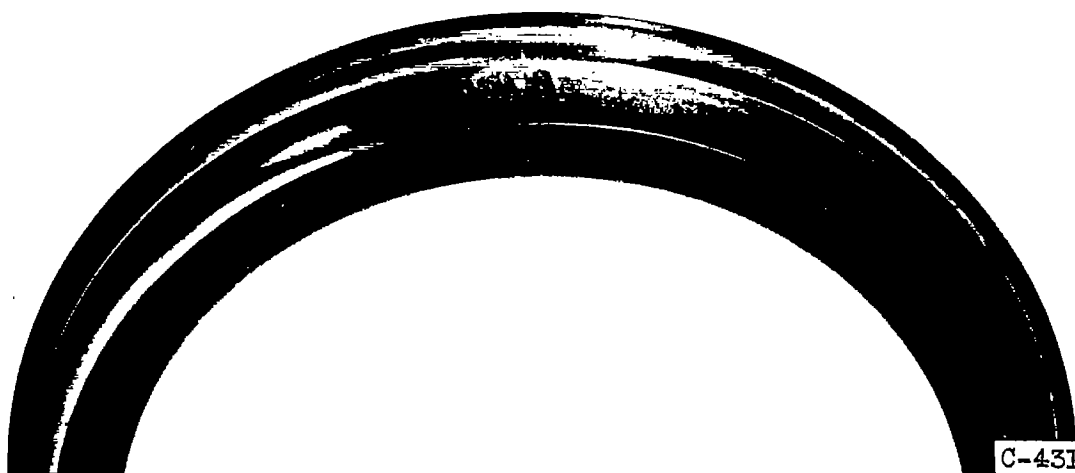
Figure 9. - Concluded. Fatigue spalls and cracks on test bearings.

The results of the fatigue tests are summarized in table I. A total of eight bearings failed in fatigue, photographs of some of these failures are shown in figure 9. Six bearings had spalled inner races, one a spalled outer race, and one a spalled outer race and four spalled balls. The basic dynamic capacity of a similar bearing of SAE 52100 steel was calculated using the standard AFBMA method (ref. 7) and found to be 30,600 pounds. Using this capacity and the bearing manufacturer's catalog, a theoretical life at each load and speed condition was calculated. Use of this data together with the running times at each condition enabled calculation of a "life fraction." This life fraction (given in table I) is the fraction of the rating life of a similar SAE 52100 steel bearing that has been consumed in these tests. None of the failed components survived a life fraction of more than 0.395.

some 15 hours running time was accumulated at temperatures of 501° to 678° F without the cage incurring any appreciable wear. During several oil-interruption tests, which cumulatively consumed 17 minutes and 22 seconds running time (table III), severe wear of the cage and extremely severe wear of both the inner and outer races occurred. The depth of wear on the cage inside and outside diameters was less than 1/64 inch, but the cage wore the inner and outer races to uniform depths of 7/64 and 1/16 inch, respectively, over the surfaces contacting the cage. A photograph of the cage of bearing 1009 is shown in figure 13(a). The inner race of bearing 1009 is shown in figure 9 and the outer race in figure 14.

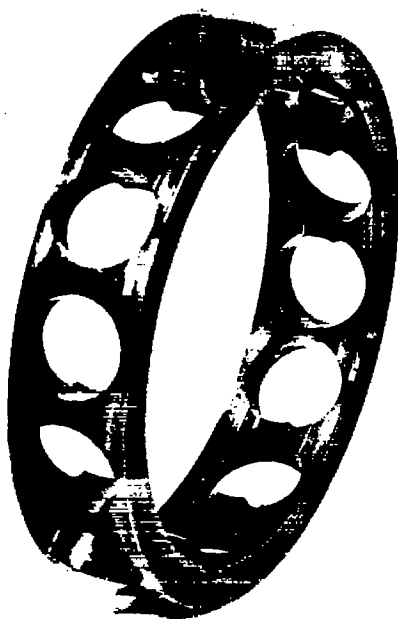
(a) Bearing 1009. Cage wear resulting from several oil-interruption tests.
